STUDIES OF THE NATURE OF WEAR

Trans-Sonics, Incorporated

TECHNICAL REPORT
STUDIES OF THE NATURE OF WEAR
PERIOD: 1 DECEMBER 1973 TO 30 JUNE 1974
CONTRACT NO. N00014-74-C-0135

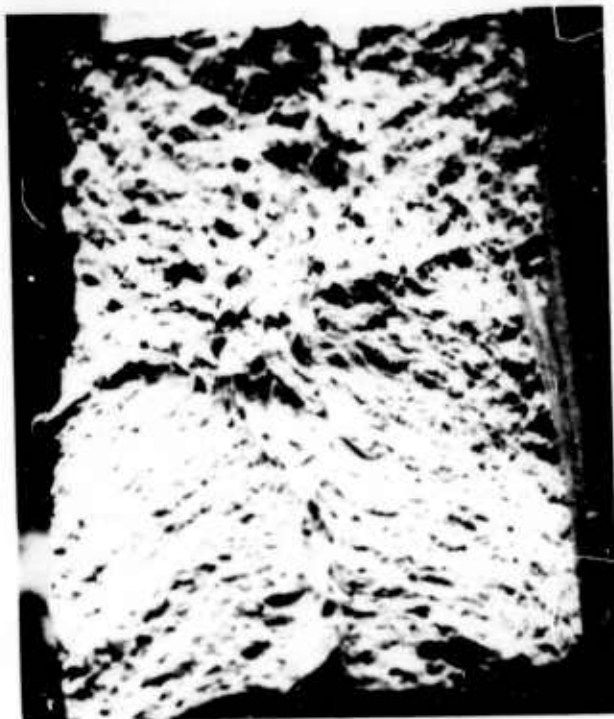
PHOTO NO. 3.1-2 DATE May 74

Wall of crack seen above. General
view of fracture surface. Fracture
initiated in lower left corner.

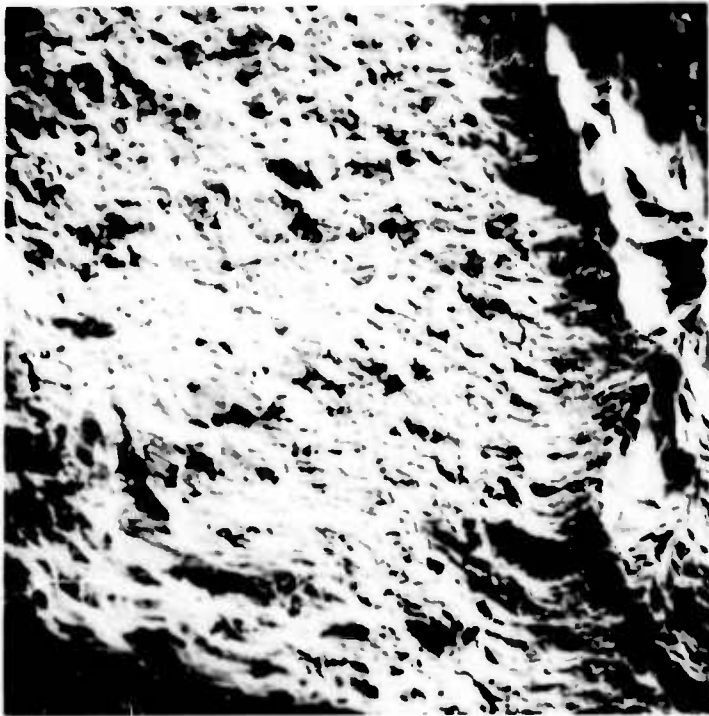
PHOTO NO. 3.1-3 DATE May 74

Initiation area of the fatigue fracture. View is of lower left corner of photo 3.1-2.

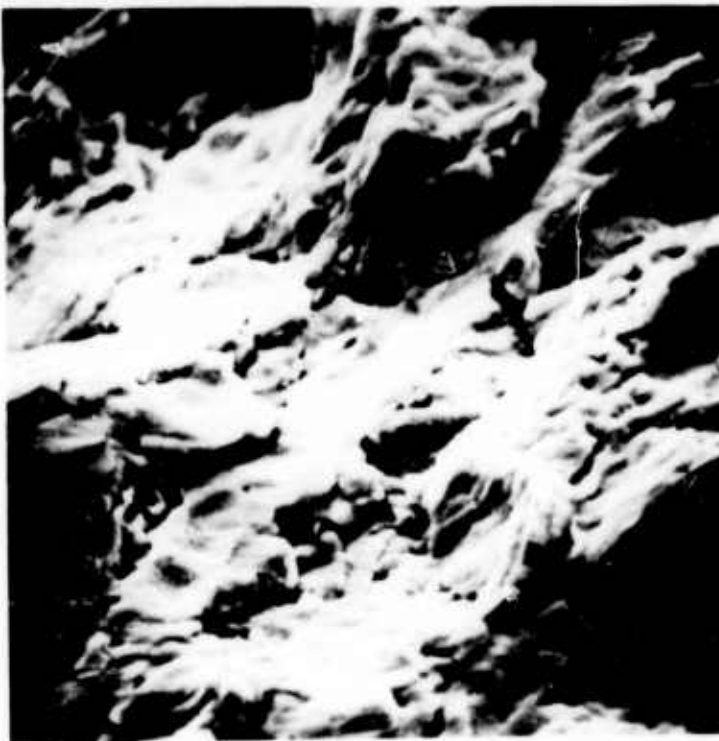
PHOTO NO. 3.1-4 DATE May 74

Same view as above with increased magnification. Note the surface shows evidence of rubbing wear.

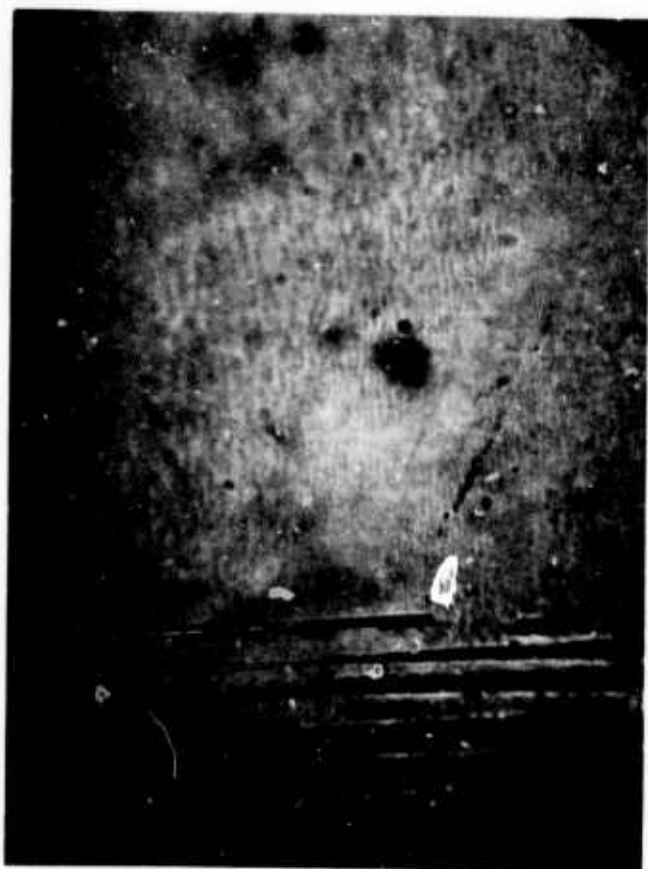
PHOTO NO. 3.2-2 DATE 5/6/74

Test No. 4102. Wear scar on the
static race.

The extreme smoothness of the wear
surface is evident. Note the
"cornices" of metal formed over
the grinding grooves at the edge
of the scar. Metal is flowing
from bottom to top.

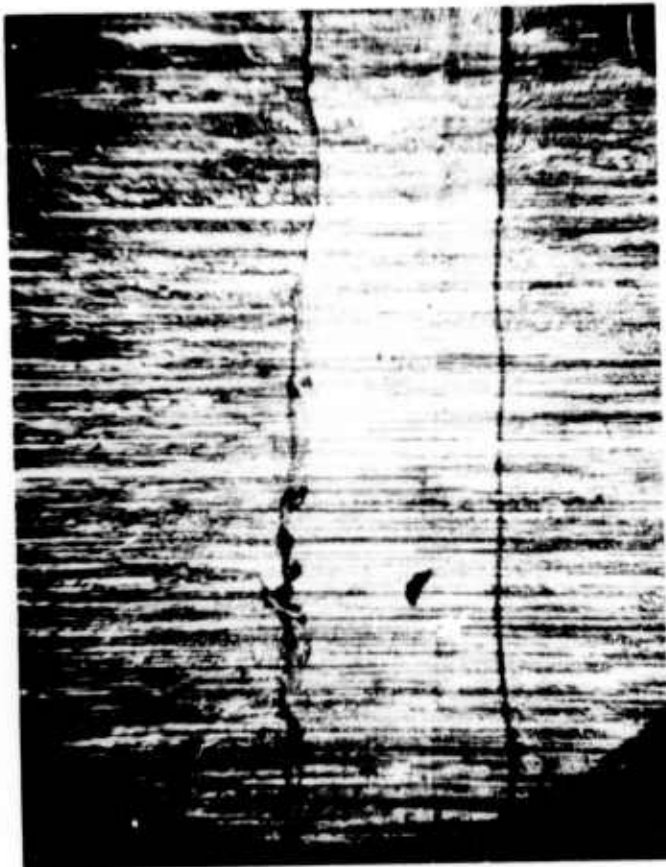
PHOTO NO. 3.2-9

Test No. 4093. Wear scar on the rotating race.

Two of general cracks or fissures found in this race at end of test. Surface still contains grooves from original finish grinding. Only the tops have been removed.

During one test using 52100 steel, a few spherical particles were observed on the Ferrograms of the later samples. These coincided with the appearance of a crack in the surface rotating piece, Photomicrograph 3.2-5.

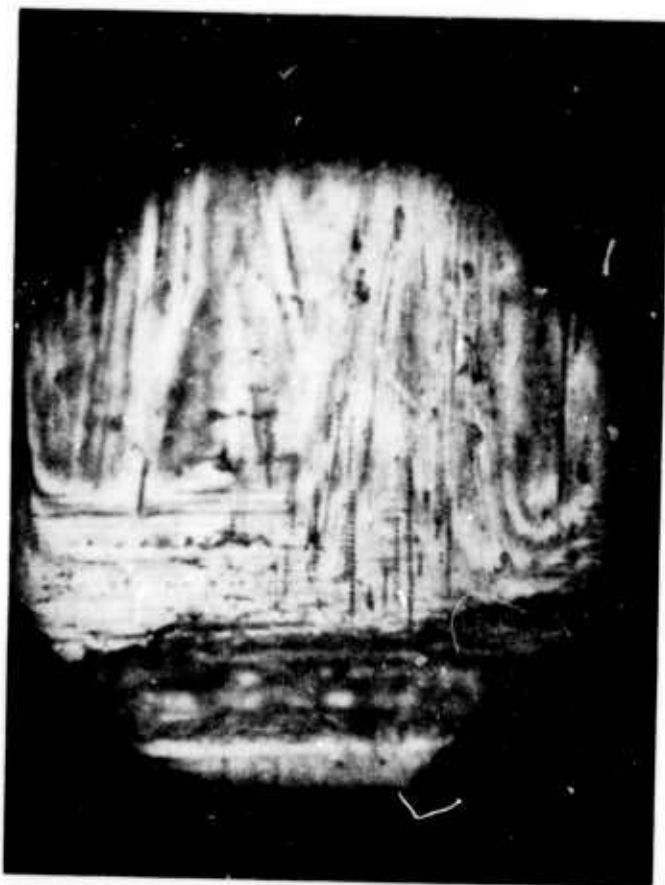
PHOTO NO. 3.3-3 DATE JULY 74

Optical photomicrograph of strings
of dark pits running parallel with
the direction of rolling motion.

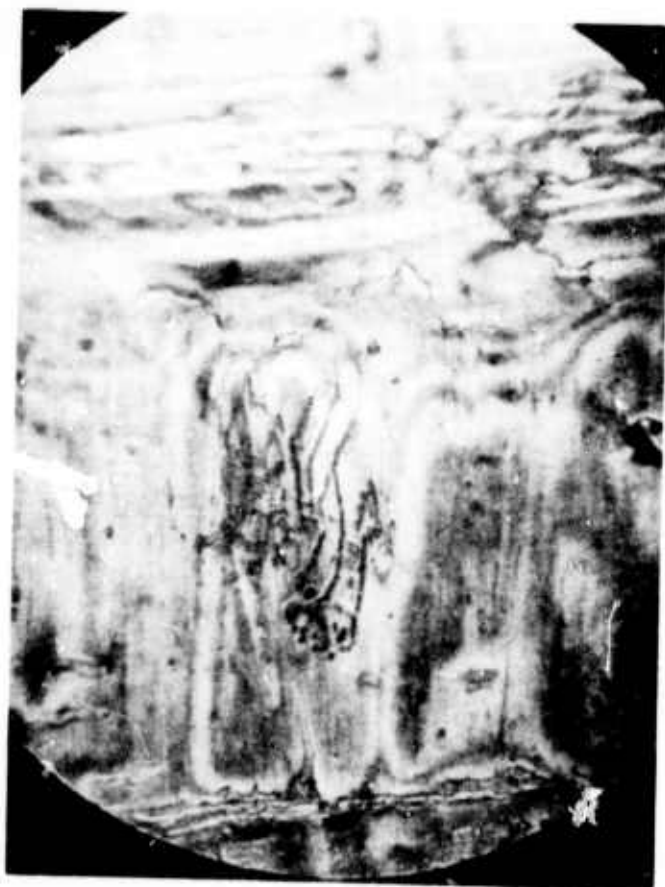
PHOTO NO. 3.3-4 DATE JULY 74

Optical photomicrograph of dark pit
network. Note parallel curved strings.

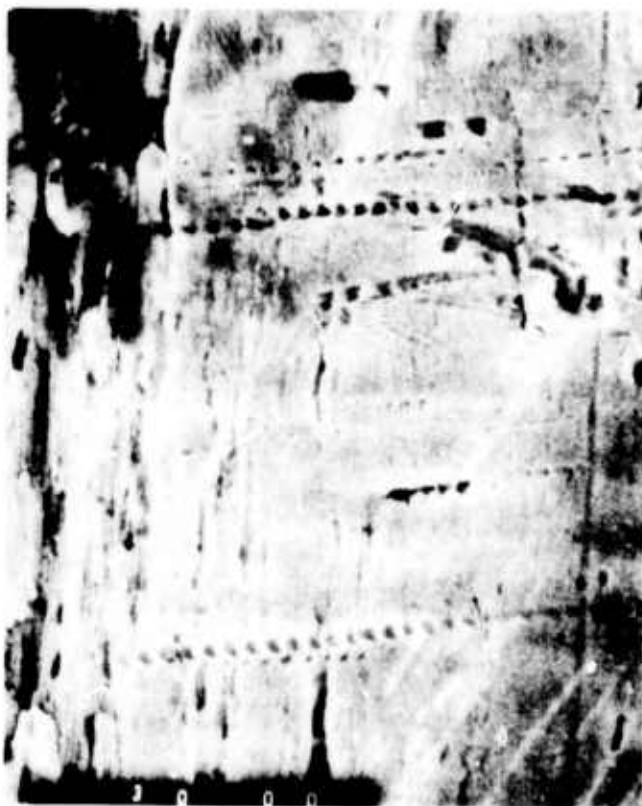
PHOTO NO. 3.3.6 DATE JULY 74

OPERATING HISTORY:
299,000 cycles at 200 R.P.M.
123 Kg force
Lubricant=MIL-L-23699 (Mobil Jet II)

REMARKS:
S.E.M. photomicrograph showing
parallel strings and parallel
curved strings.

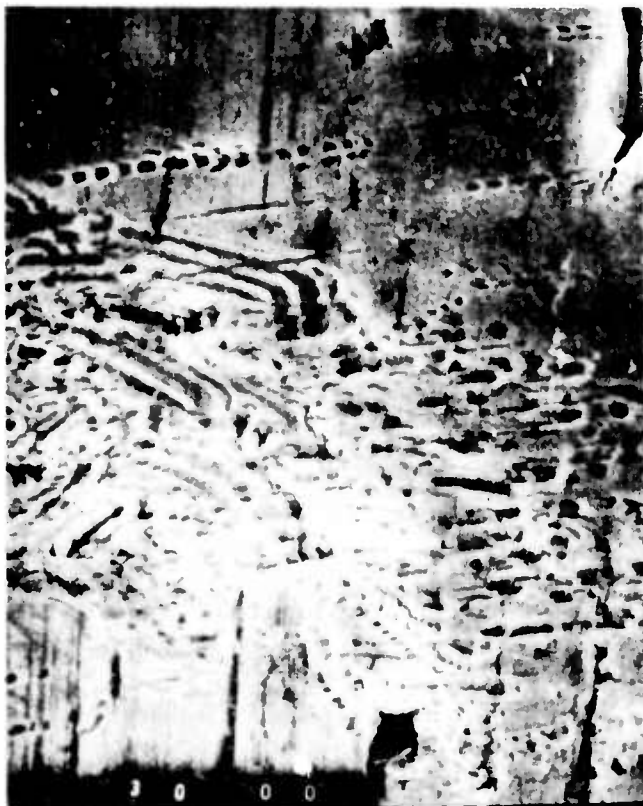
PHOTO NO. 3.3-7 DATE JULY 74

S.E.M. photomicrograph showing network of pits.
